HANDLING INSTRUCTIONS for DISPENSA VVS-x

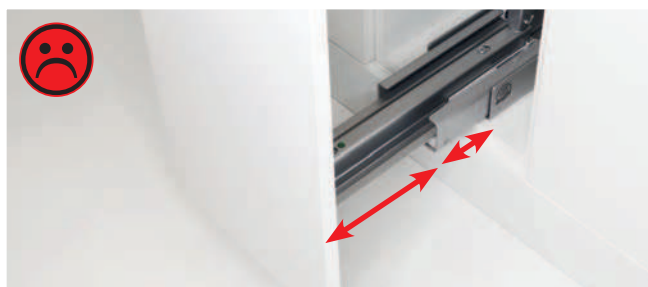
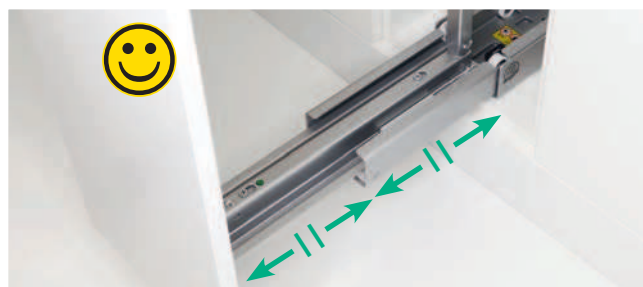
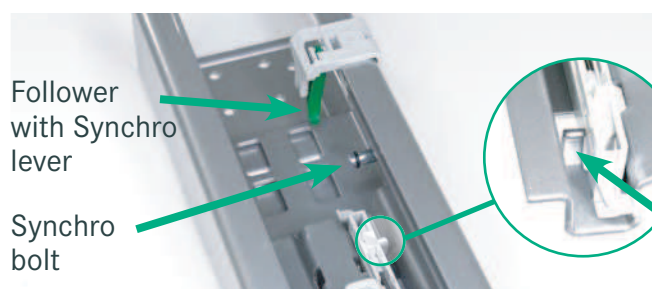
1.1 Shifted segment: Synchronomatic defective

For Synchronomatic to work correctly, all components must be present and correctly installed.

Problem	Possible cause	Possible solution (summary)	Full information
1. Door will not close completely	1. Shifted segment; Synchromatic defective.	Replace follower with Synchro lever.	1.1

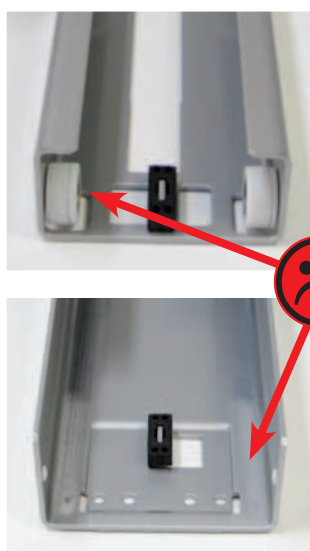
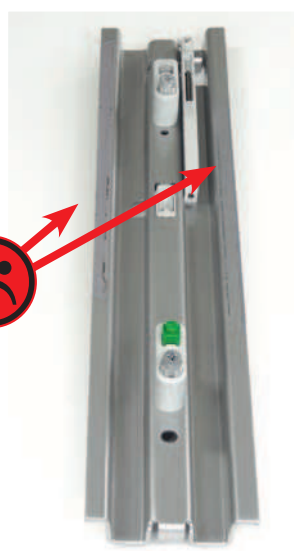
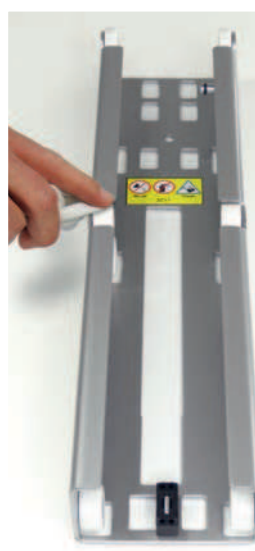
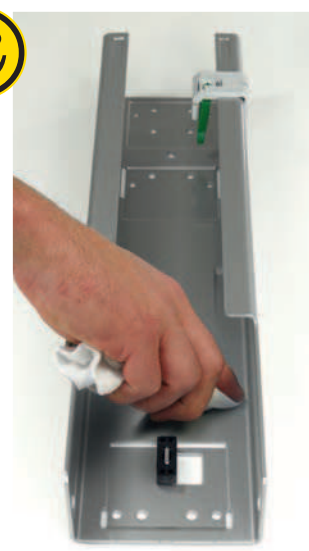
1.2 Bottom runner dirty (due to dirt, foreign particles, lubricant)?

Clean rollers and running surfaces!

There must be no dirt on the bottom runner, especially the base element: Wipe dry dirt off with a dry cloth. If there is oil or grease on the runner, you will need to clean the whole element (running surfaces, roller surfaces and rollers), e.g. with glass cleaner. The runner may need to be replaced.

Never use oil or other lubricants on the segments!

2. Bottom runner dirty.	Clean the runner. (No oil!)	1.2
	3. Connection between support frame and bottom runner is loose.	Check the connection between the frame and the bottom runner and tighten if necessary.	1.3

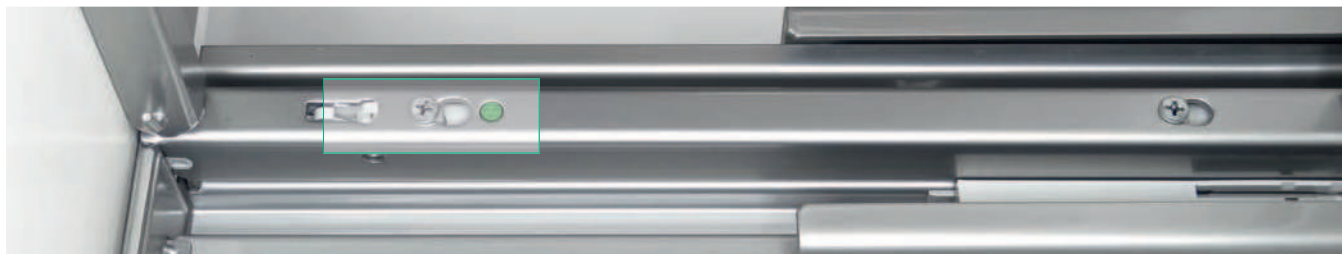
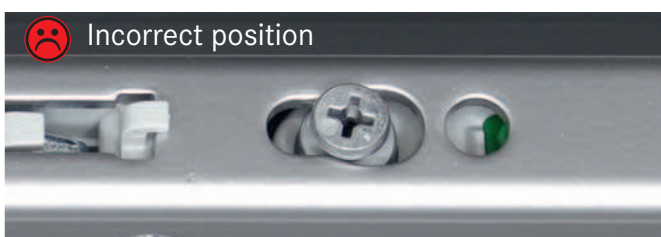
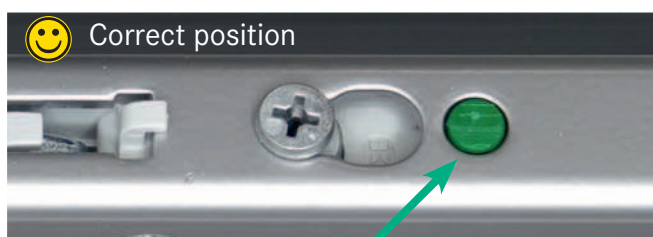
1.3 Faulty connection between the pull-out frame and bottom runner

Check that the pull-out frame is correctly positioned on the bottom runner!

Locking pin

1. Do not use a cordless screwdriver!

2. The green locking pin must click into position and be fully visible.

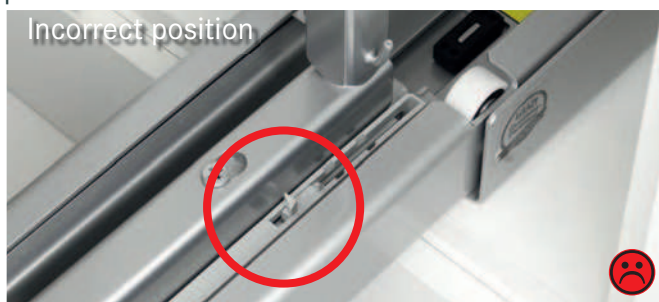
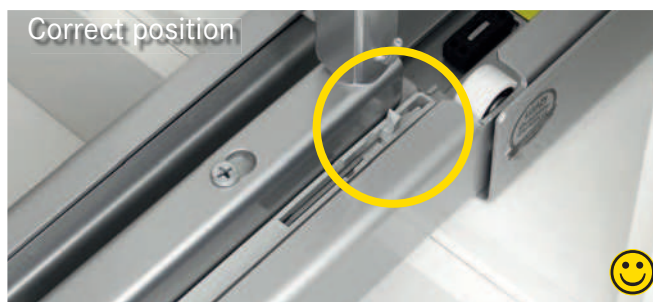
1.4 Bottom damper (optional) unlatched

If the bottom damper is in the wrong position, reactivate the function by pushing the front panel against the cabinet until you hear the mechanism engage. Alternatively, push the damper mechanism manually back into position.

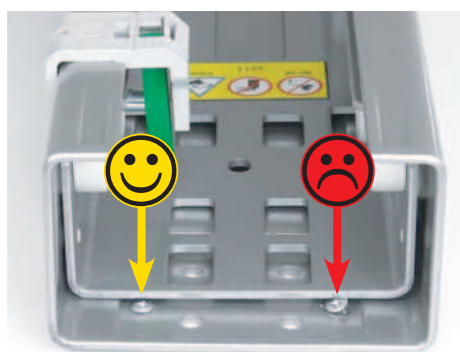
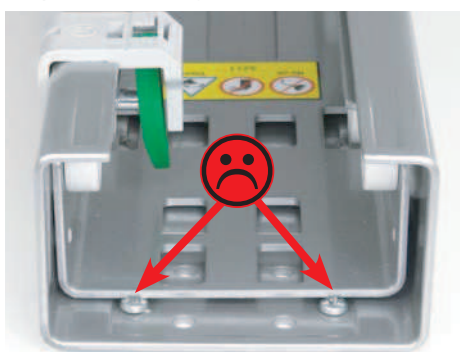
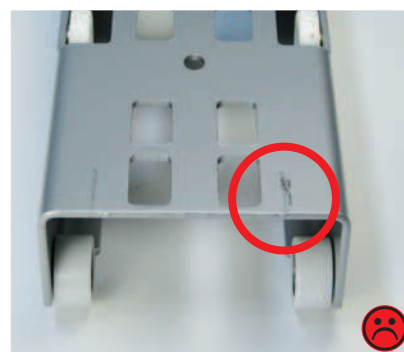
1.5 Are the screws tight? Are you using the correct screws?

1. Do not overtighten the screws!

2. The screws used must not come into contact with the middle slide!

3. The screws must be straight and firmly tightened (check the middle slide for signs of wear!)

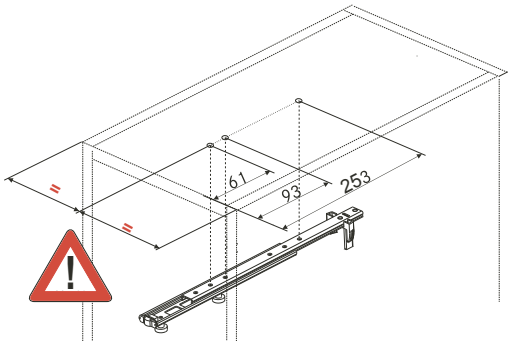
1.6 Are the runners mounted parallel (i.e. drilling positions correct)?

Top runner parallel to side panel?

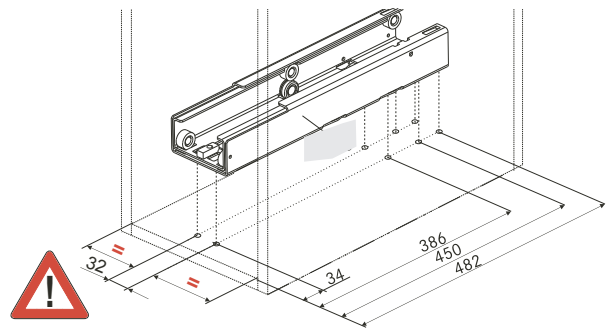
Bottom runner parallel to side panel?

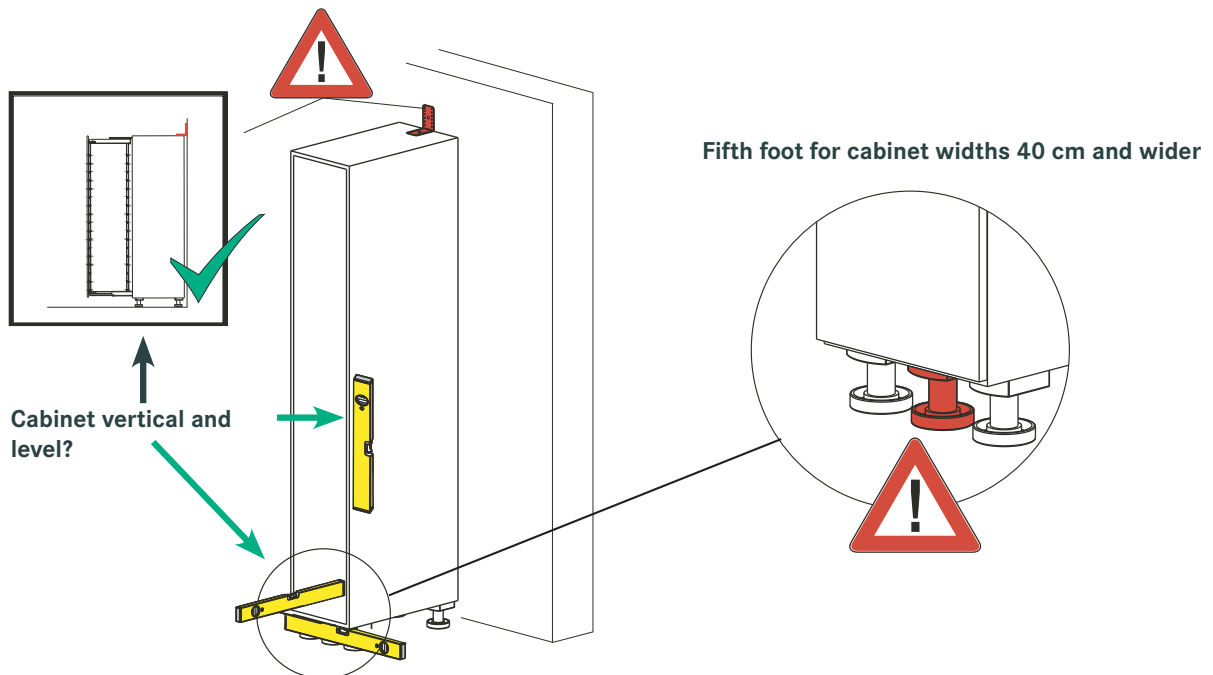
1.7 Has the cabinet been assembled properly?

a) Is the cabinet vertical and level?

1. The side panels must be straight and vertical.
2. The bottom panel must be horizontal.
3. The cabinet must be fixed securely to the wall.

Fifth foot correctly installed for cabinets 40 cm and wider?

For cabinets 40 cm and wider, check that the fifth foot is positioned centre front and has been correctly adjusted/tightened. If the foot is not correctly installed, the bottom panel may sag, causing problems with closing.

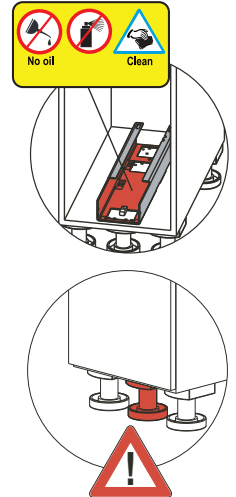
2.1 Bottom runner dirty (due to dirt, foreign particles, lubricant)?

Wipe dry dirt off with a dry cloth. If there is oil or grease on the runner, you will need to clean the whole element (running surfaces, roller surfaces and rollers), e.g. with glass cleaner. The runner may need to be replaced.

Never use oil or other lubricants on the segments!

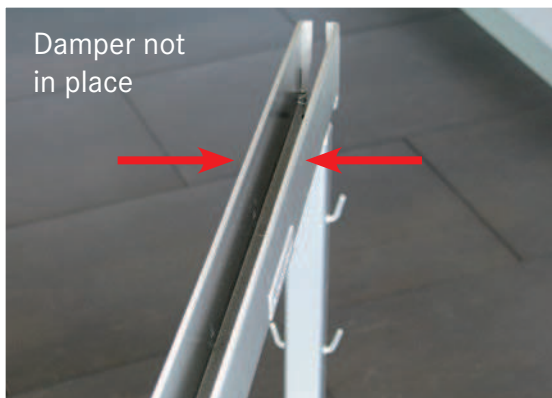
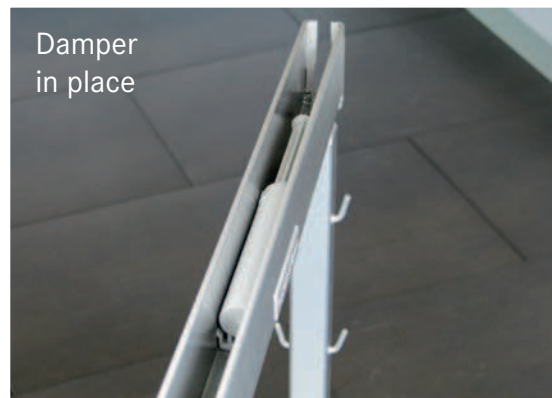
3.1 Is the top damper in place?

A damper can be ordered from the furniture manufacturer. Install it in the frame so that it locks in position.

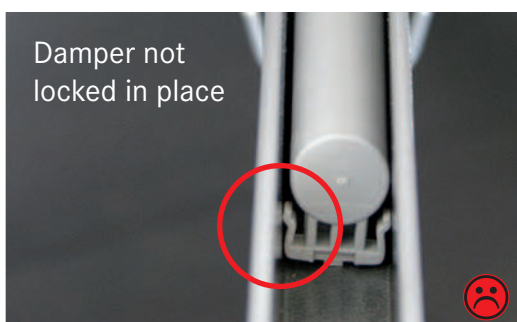
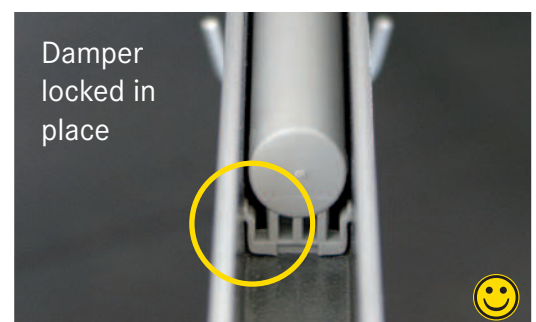
3.2 Is the top damper locked in place?

Move damper until it locks in place!
